WI-167
Brady House
Quantico
Private

Maryland Historical Trust State Historic Sites Inventory Form

MARYLAND INVENTORY OF HISTORIC PROPERTIES

Brady house description (continued)
Quantico, Wicomico County, Maryland

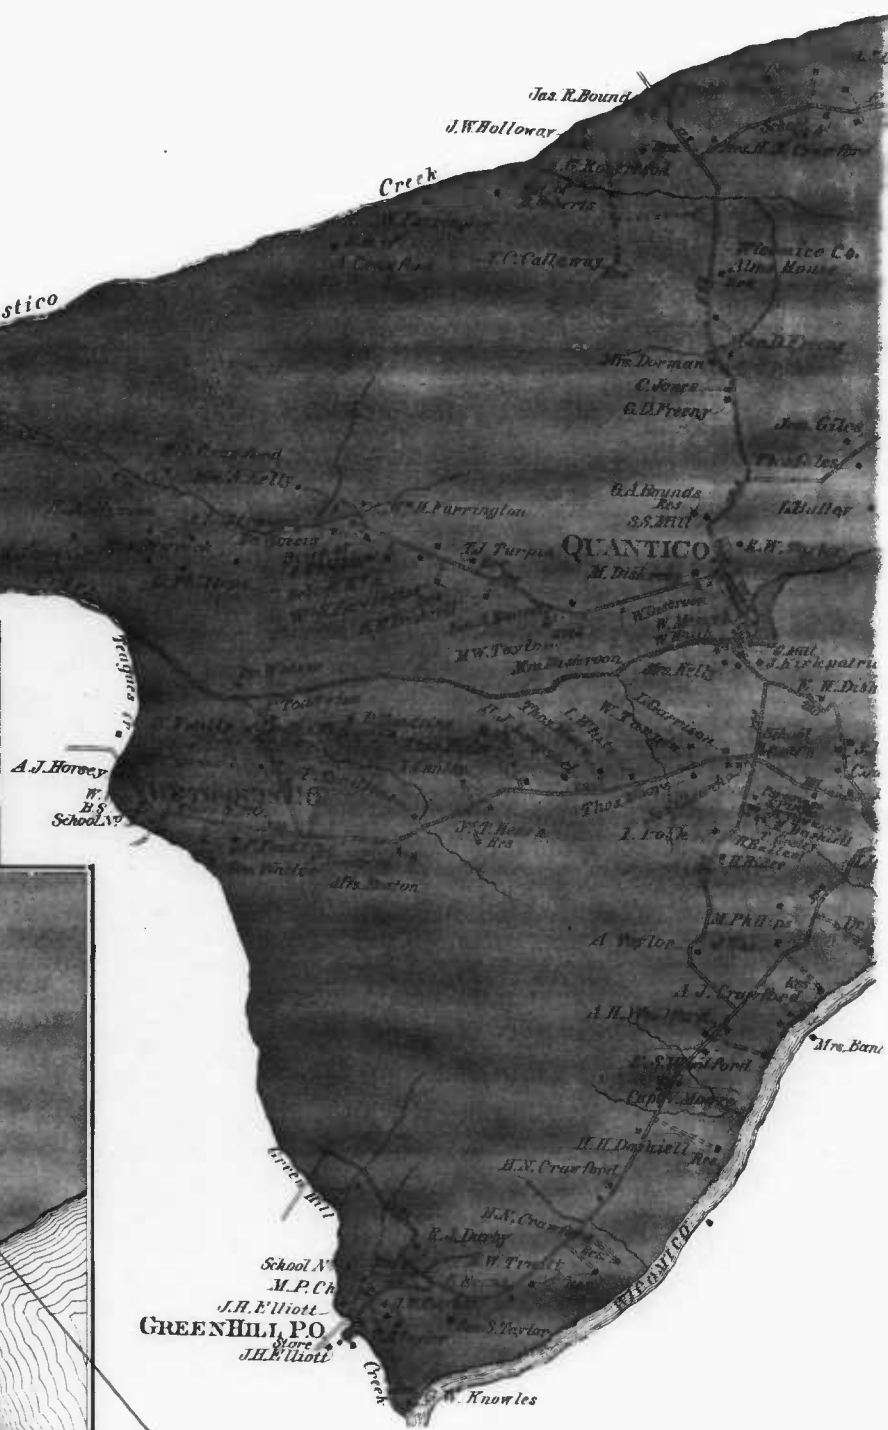
WI-167
Brady House

1877 Lake, Griffing, and Stevenson
Atlas

Chain of title research for the early nineteenth century has been established for this property, however the house and lot were owned by Andrew J. Crawford when the Lake, Griffing, and Stevenson atlas was published in 1877. Standing on the lot north of the house was the Crawford & Bounds store. The next year, in January 1878, Andrew J. Crawford and his wife Mary and others sold the house and lot to Eleanor S. A. Woolford for \$600. Fourteen years later, in April 1892, estate trustee James E. Ellegood sold the Woolford house to Washingtonian, Sallie L. Walker. The property remained in Walker family hands until the early 1970s.

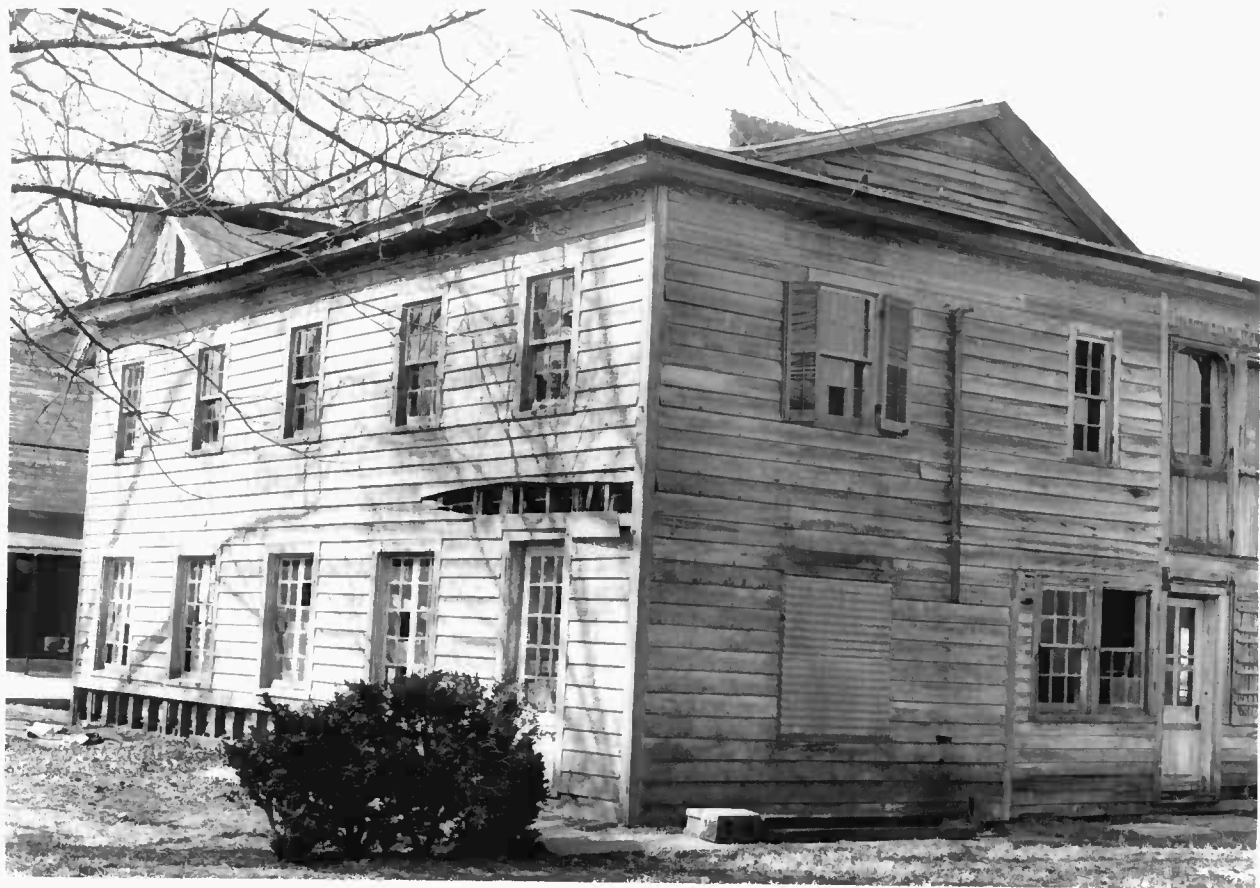
WI-167

Southeast elevation

Initially built around 1820, the two-story, three-bay main block is supported on a brick pier and concrete block foundation, and the house is sheathed with a combination of original and replacement beaded weatherboarding. The medium sloped gable roof is covered with asphalt shingles. Attached to the back of the house is a two-story, two-room plan service wing that was added to the front block around 1840. This service wing had a stepped profile originally since the kitchen section only rose to a story-and-a-half height. Around 1900, the kitchen roof was raised to the same level as the dining room portion of the rear wing. At the same time several small rooms, including a pantry, were attached to the north and east sides of the kitchen in order to increase convenience and living space of the kitchen. Finally, around 1925, the wing was extended on the south side with a two-story, five-bay shed roofed addition.

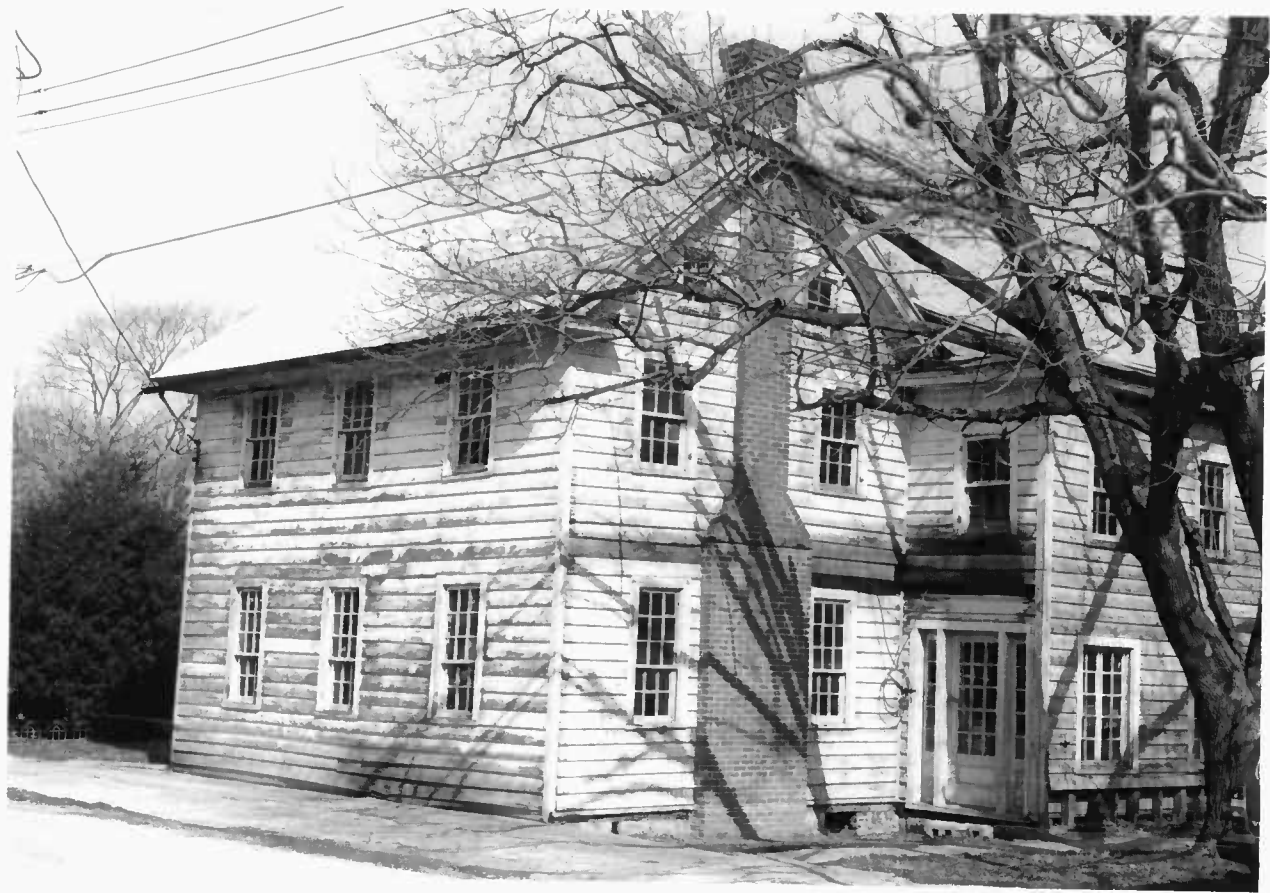
WI-167

Southwest elevation

The west (main) facade is a symmetrical three-bay elevation with nine-over-six sash windows filling each of the first floor bays. The northernmost bay was originally a doorway, but during the early twentieth remodeling of the main house, the opening was converted to a window. The window sash are twentieth century replacements. The second floor is pierced by three replacement six-over-six sash windows. During the twentieth century remodeling of the house, the eaves were rebuilt and extended slightly in front as well as on each side.

Distinguishing the opposite gable end is a partial exterior brick chimney erected during the early twentieth century. Nine-over-six sash windows flank the stack on the first floor, and six-over-six sash windows light the second floor. Small two-over-two sash windows illuminate the attic.

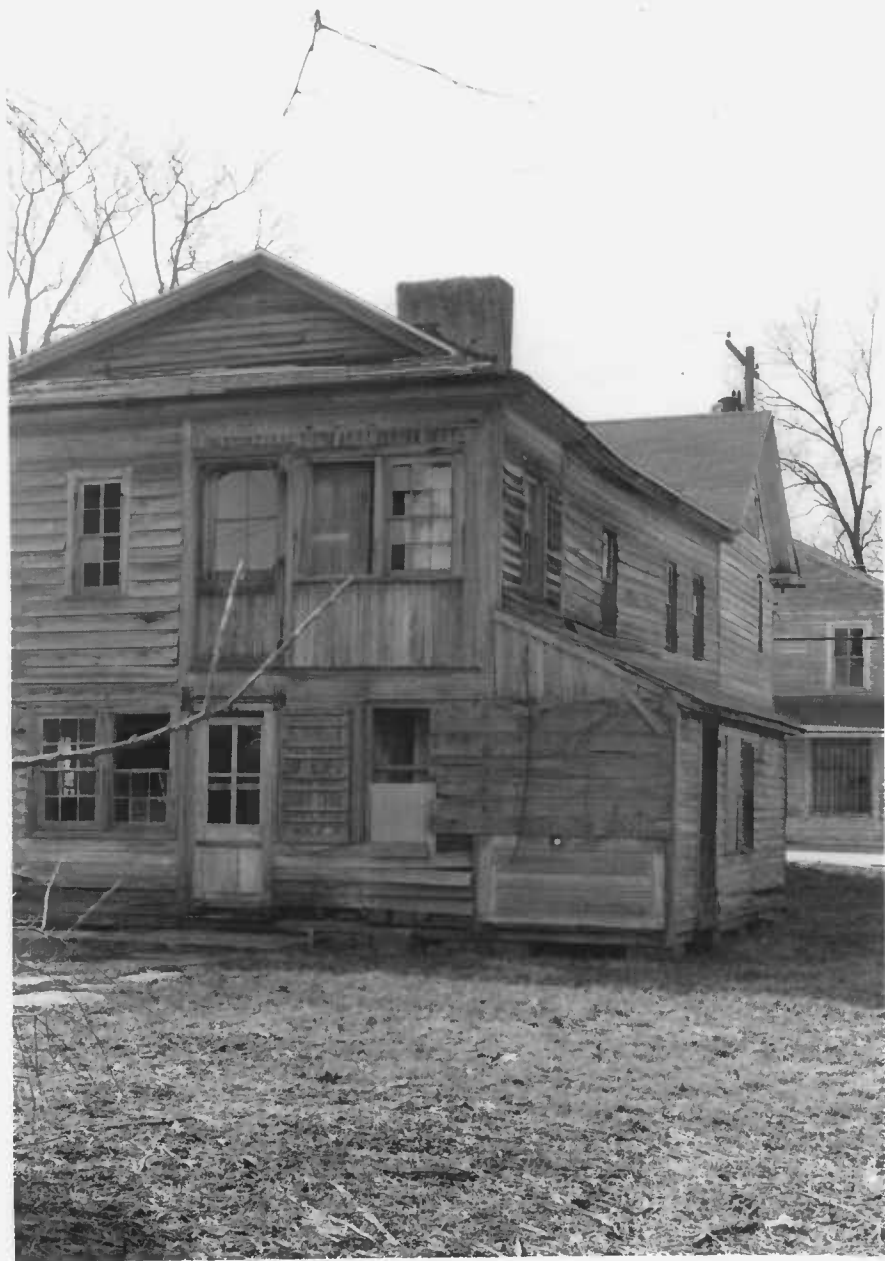
WI-167

Northeast elevation

The east side of the main block is fully covered by the rear two-story service wing. Rising in the center of the wing is a large brick stack that contains four flues. The exterior of the service wing is clad with plain weatherboards and pierced by six-over-six sash windows.

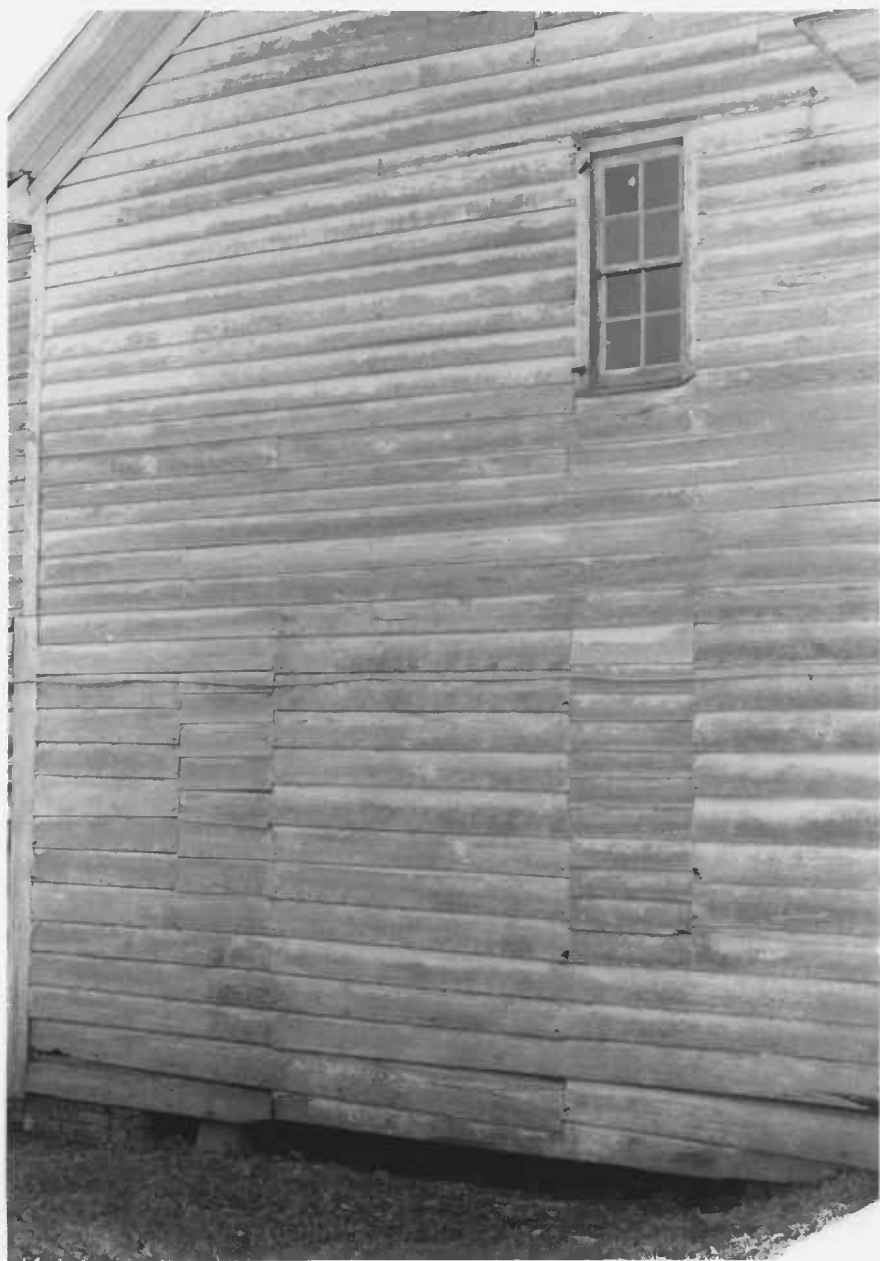
WI-167

North gable end with boarded over
window openings

The north side of the main block is the only wall that retains portions of original beaded weatherboarding. Two rectangular patches on the first floor cover former six-over-four sash windows. The second floor retains an original four-over-four sash window, and the attic is lighted by small two-over-two sash windows.

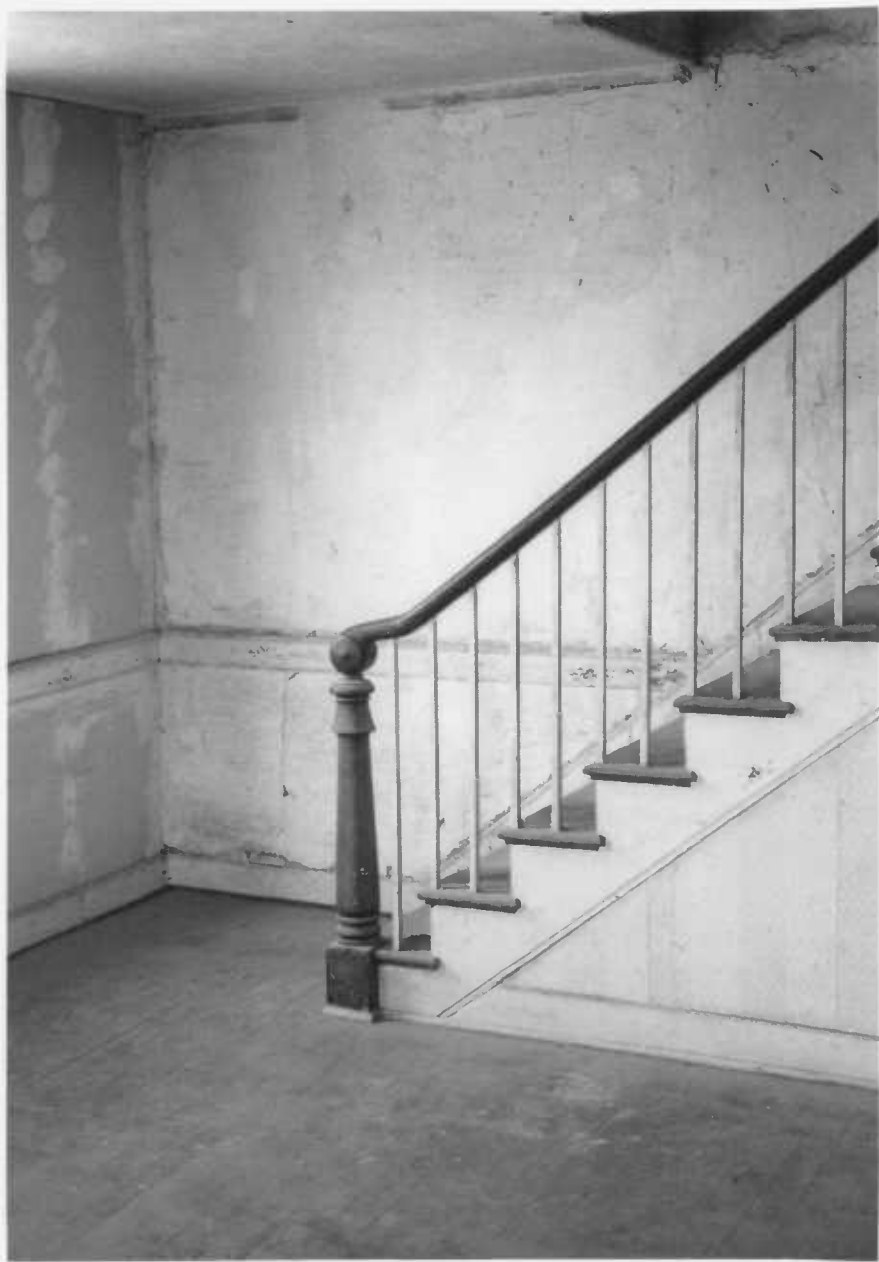
WI-167

Quantico, Wicomico County, Maryland
Stair

The interior of the main block has been modified at various times. Mature cut nails, riven lath, and Federal woodwork comfortably place its construction around 1820. The first floor originally followed a side hall/parlor plan with an off-center partition separating the hall from the parlor. The original stair was fixed against the partition directly underneath the attic stair. This floor plan was altered around 1840 when the rear wing was attached. The original stair, probably an enclosed or boxed stair, was taken out and replaced with the extant stair, built across the north gable end. The stair relocation required the blocking of two six-over-four sash windows on the first floor and the patching of the plaster wall within the stairwell. The bold turned newel post, rectangular balusters, and the two-panel stair closet door are typical of the 1840s. The workmanship of the handrail, as it joins the newel post in a well-crafted scroll, is a personal solution and not typical of period designs. Remaining inside the closet is the original six-over-four sash window that retains an early coat of paint. Fixed against the south parlor wall is a brick fireplace dating from the early twentieth century remodeling. The original woodwork in the parlor includes window surrounds and sections of chair rail and baseboard moldings.

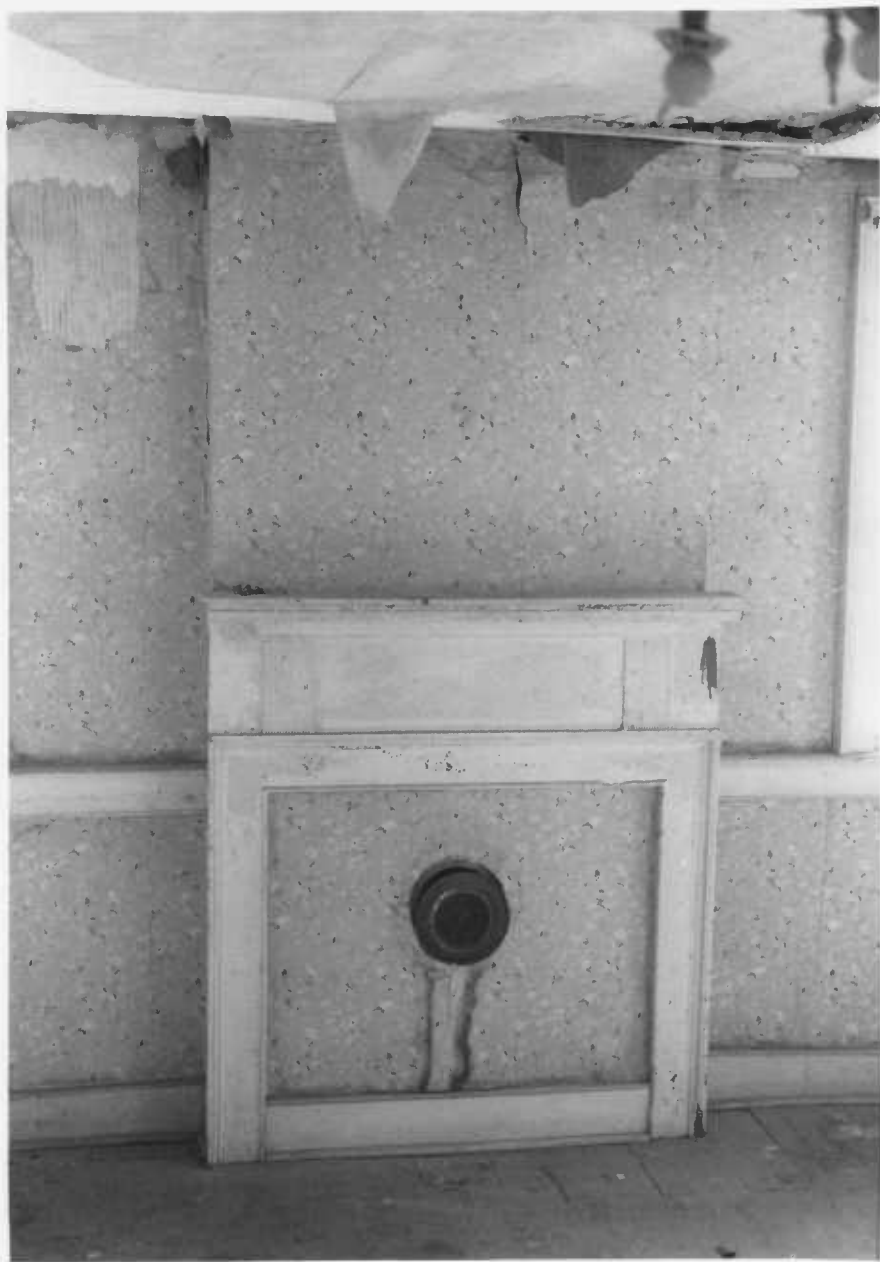
WI-167

Second floor front bedroom mantel

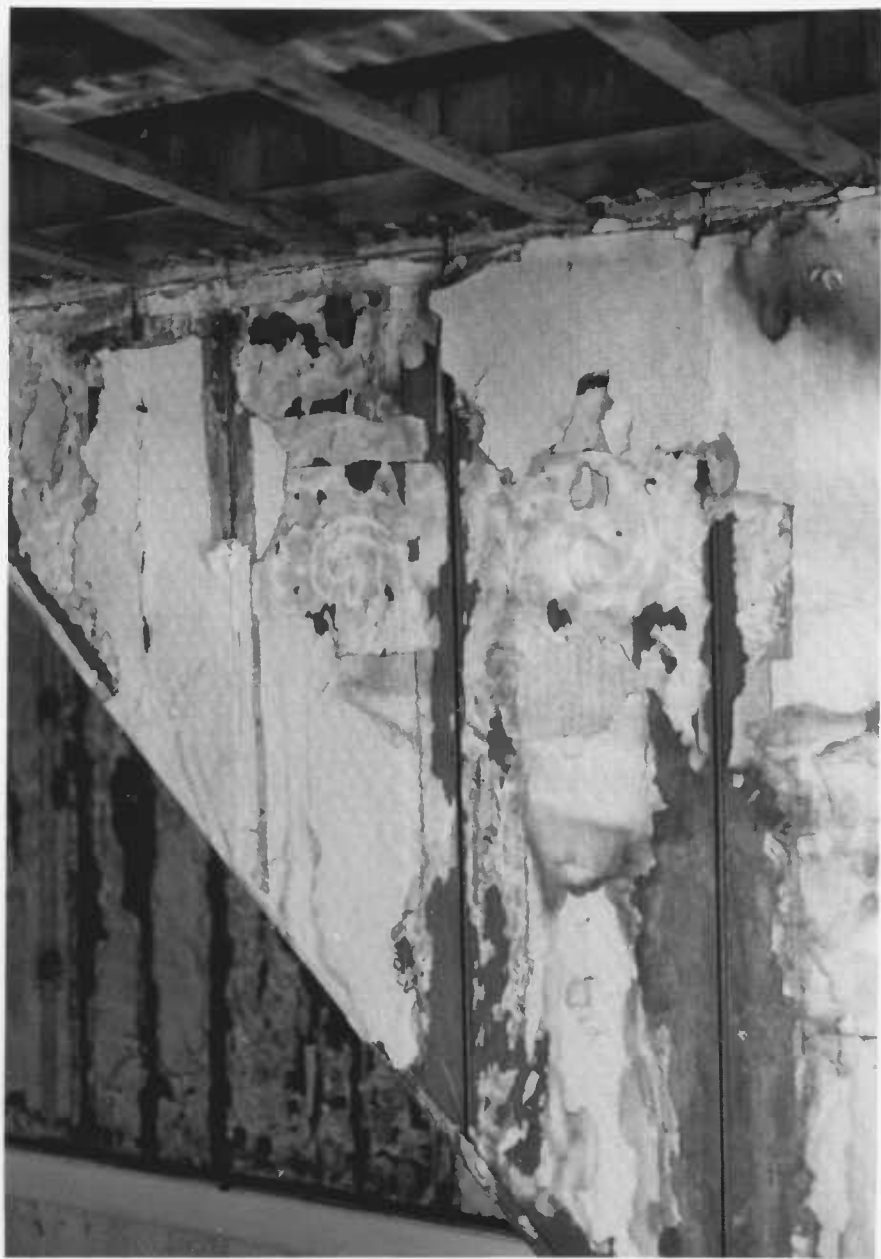
WI-167

Quantico, Wicomico County, Maryland
Second floor beaded board wall that
encloses attic stair

The second floor has been less changed with an original beaded board partition dividing the upstairs hall from the bedroom. Under the layers of wallpaper is an early blackish-blue coat of paint. A small corner closet, a turn of the century addition to the hall, is fixed in the southeast corner. Providing access to the bedroom is a four-panel door dating from the mid-to-late nineteenth century. The bedroom survives with a Federal style mantel, chair rail and beaded edge baseboard. A beaded board door provides access to the attic. A much later door opening, located in the southeast corner, opens into the early twentieth century addition.

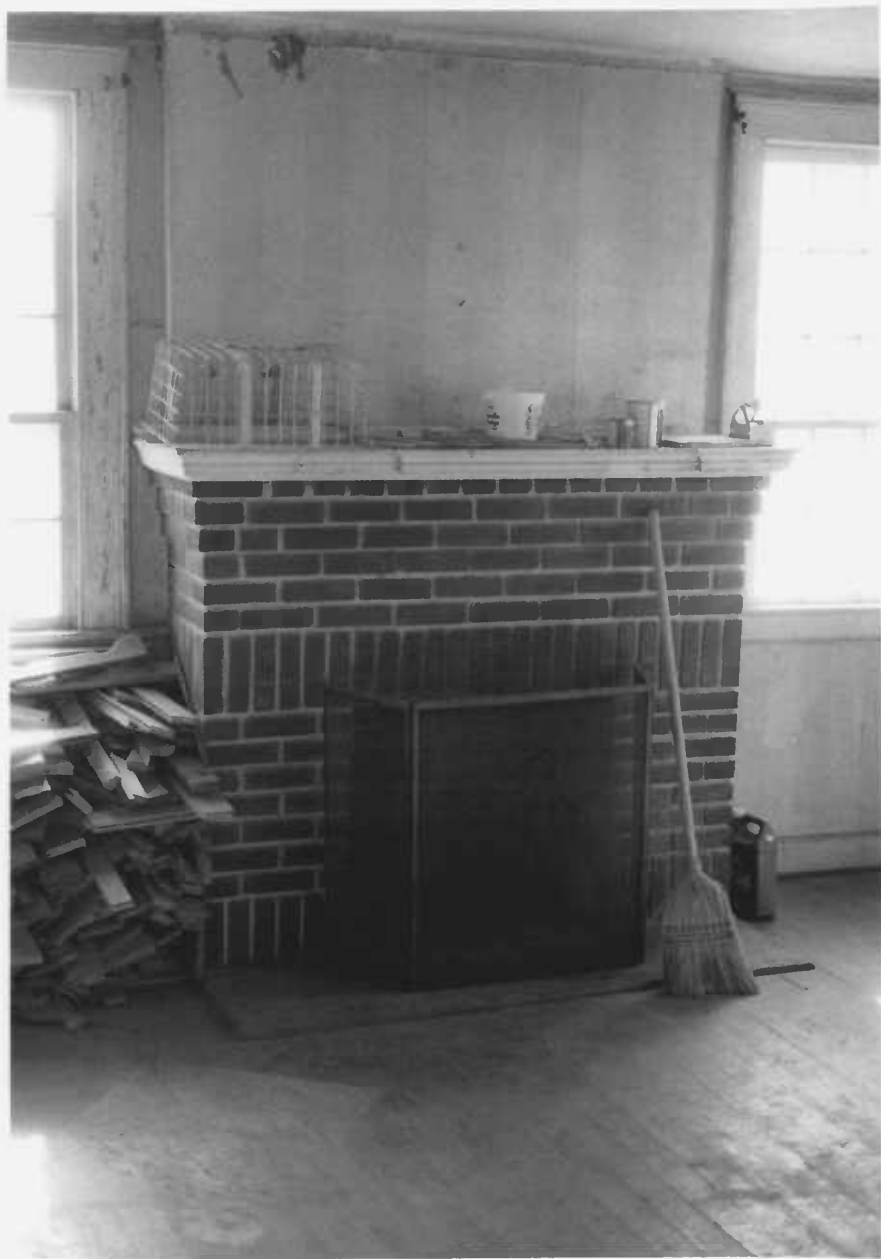
WI-167

First floor brick mantel

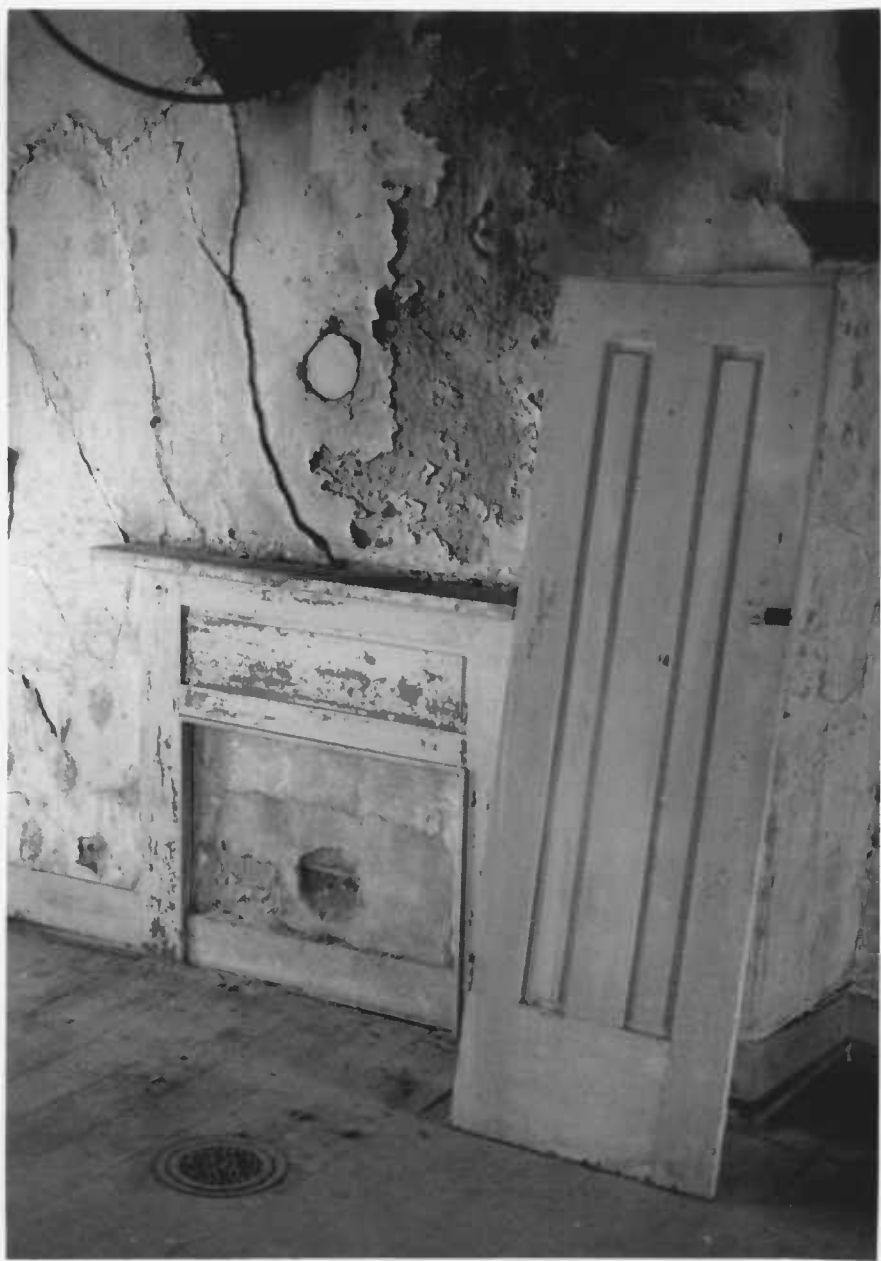
WI-167

Second floor mantel and door

The second floor of the rear wing retains some Greek Revival two-panel doors and a period mantel in the bedroom above the dining room. Although a two-panel door opens into the rear kitchen bedroom, this doorway was introduced after the kitchen roof was raised. Inside the kitchen bedroom, the original fireplace has been reworked and a large Colonial Revival mantel with detached columns and a broad mantel shelf has been attached to the chimney breast. While the flooring and hearth date from the 1840s, the shift to sawn lath and the nail holes in the gable end studs of the dining room bedroom wall indicate the later changes made to the kitchen bedroom.

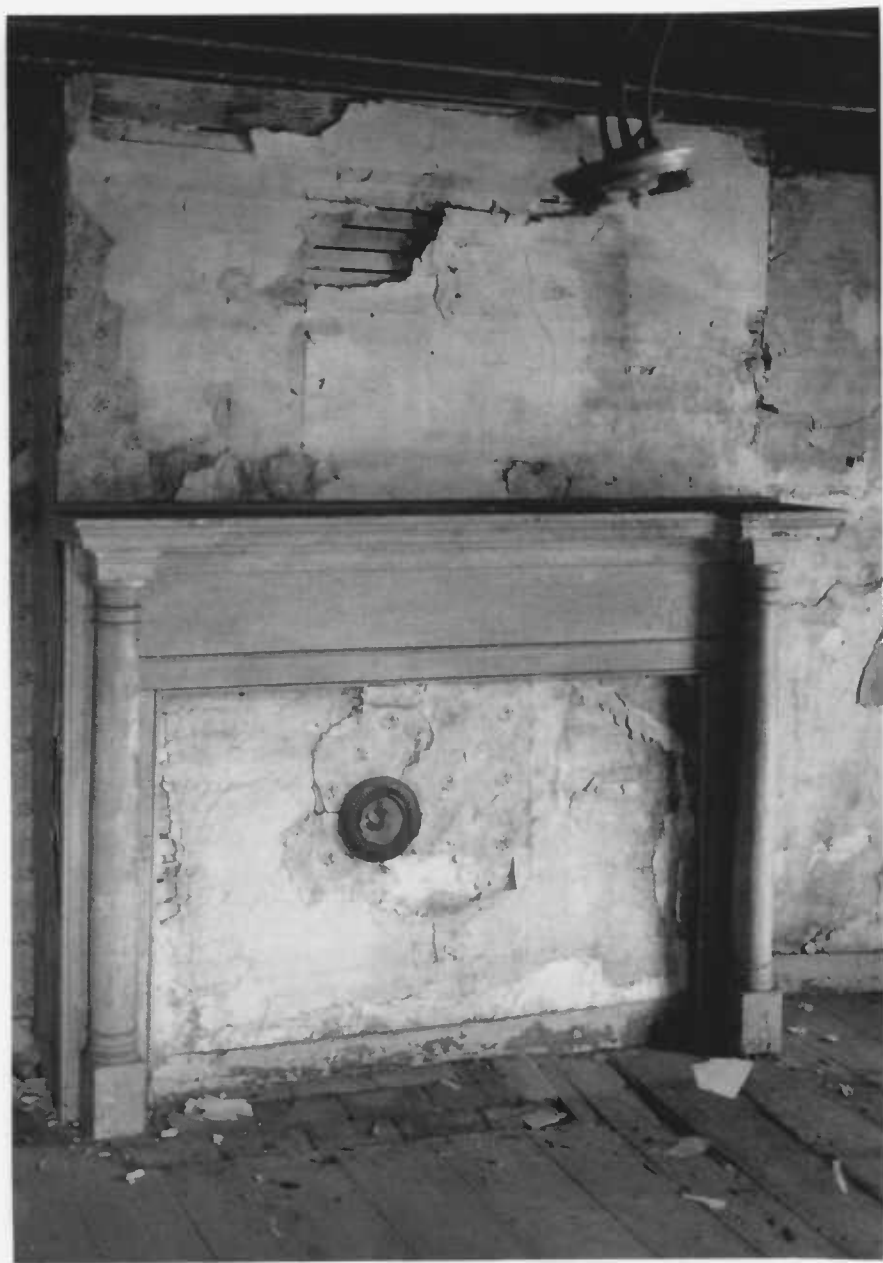
WI-167

Second floor back bedroom mantel

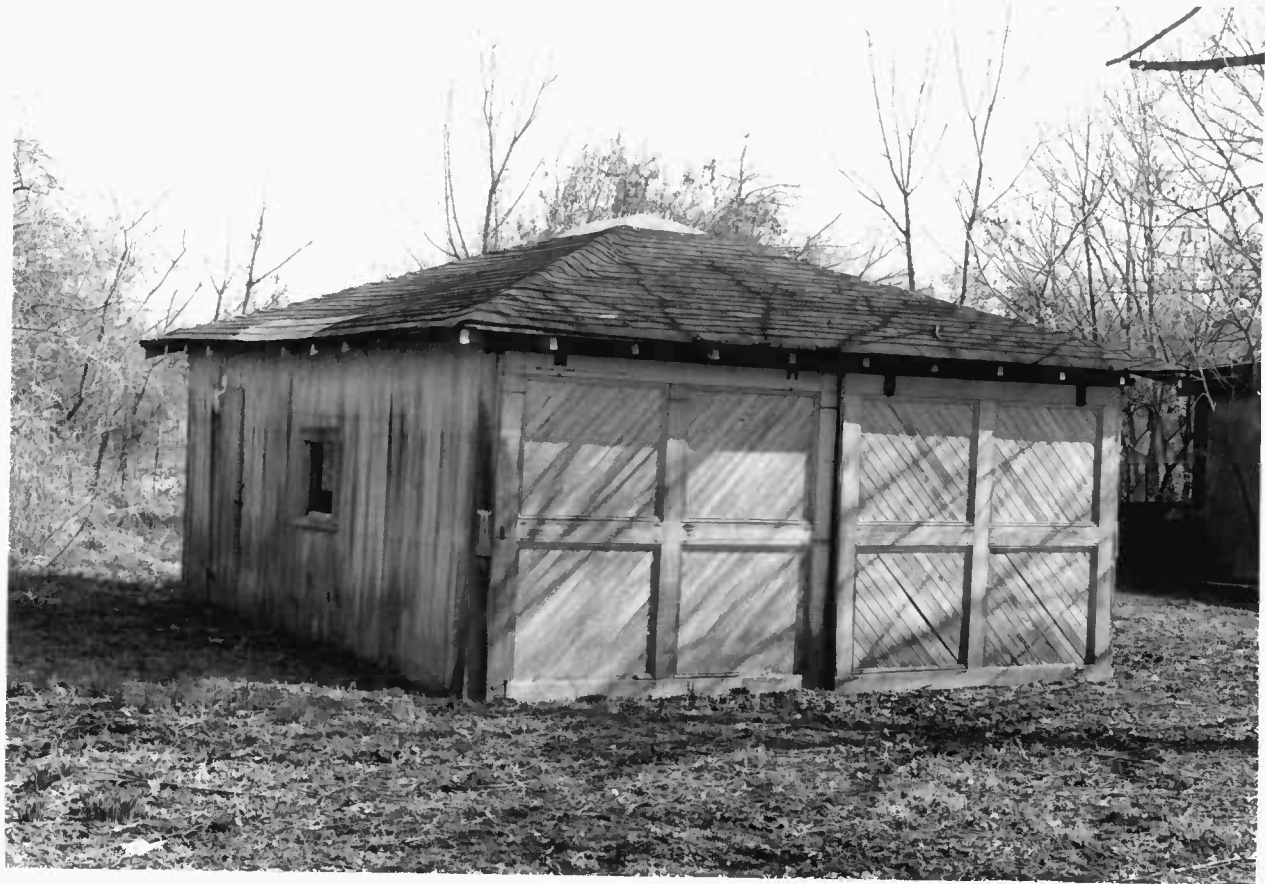
WI-167

Northwest elevation of garage

Standing behind the house is an early twentieth century hip roofed frame garage with vertical board walls and a double sliding door. The sliding door panels consist of diagonal beaded board construction.
